NASA Technical Memorandum TM 107554

Debris/Ice/TPS Assessment And Integrated Photographic Analysis For Shuttle Mission STS-52

December 1992

Gregory N. Katnik
NASA/Kennedy Space Center

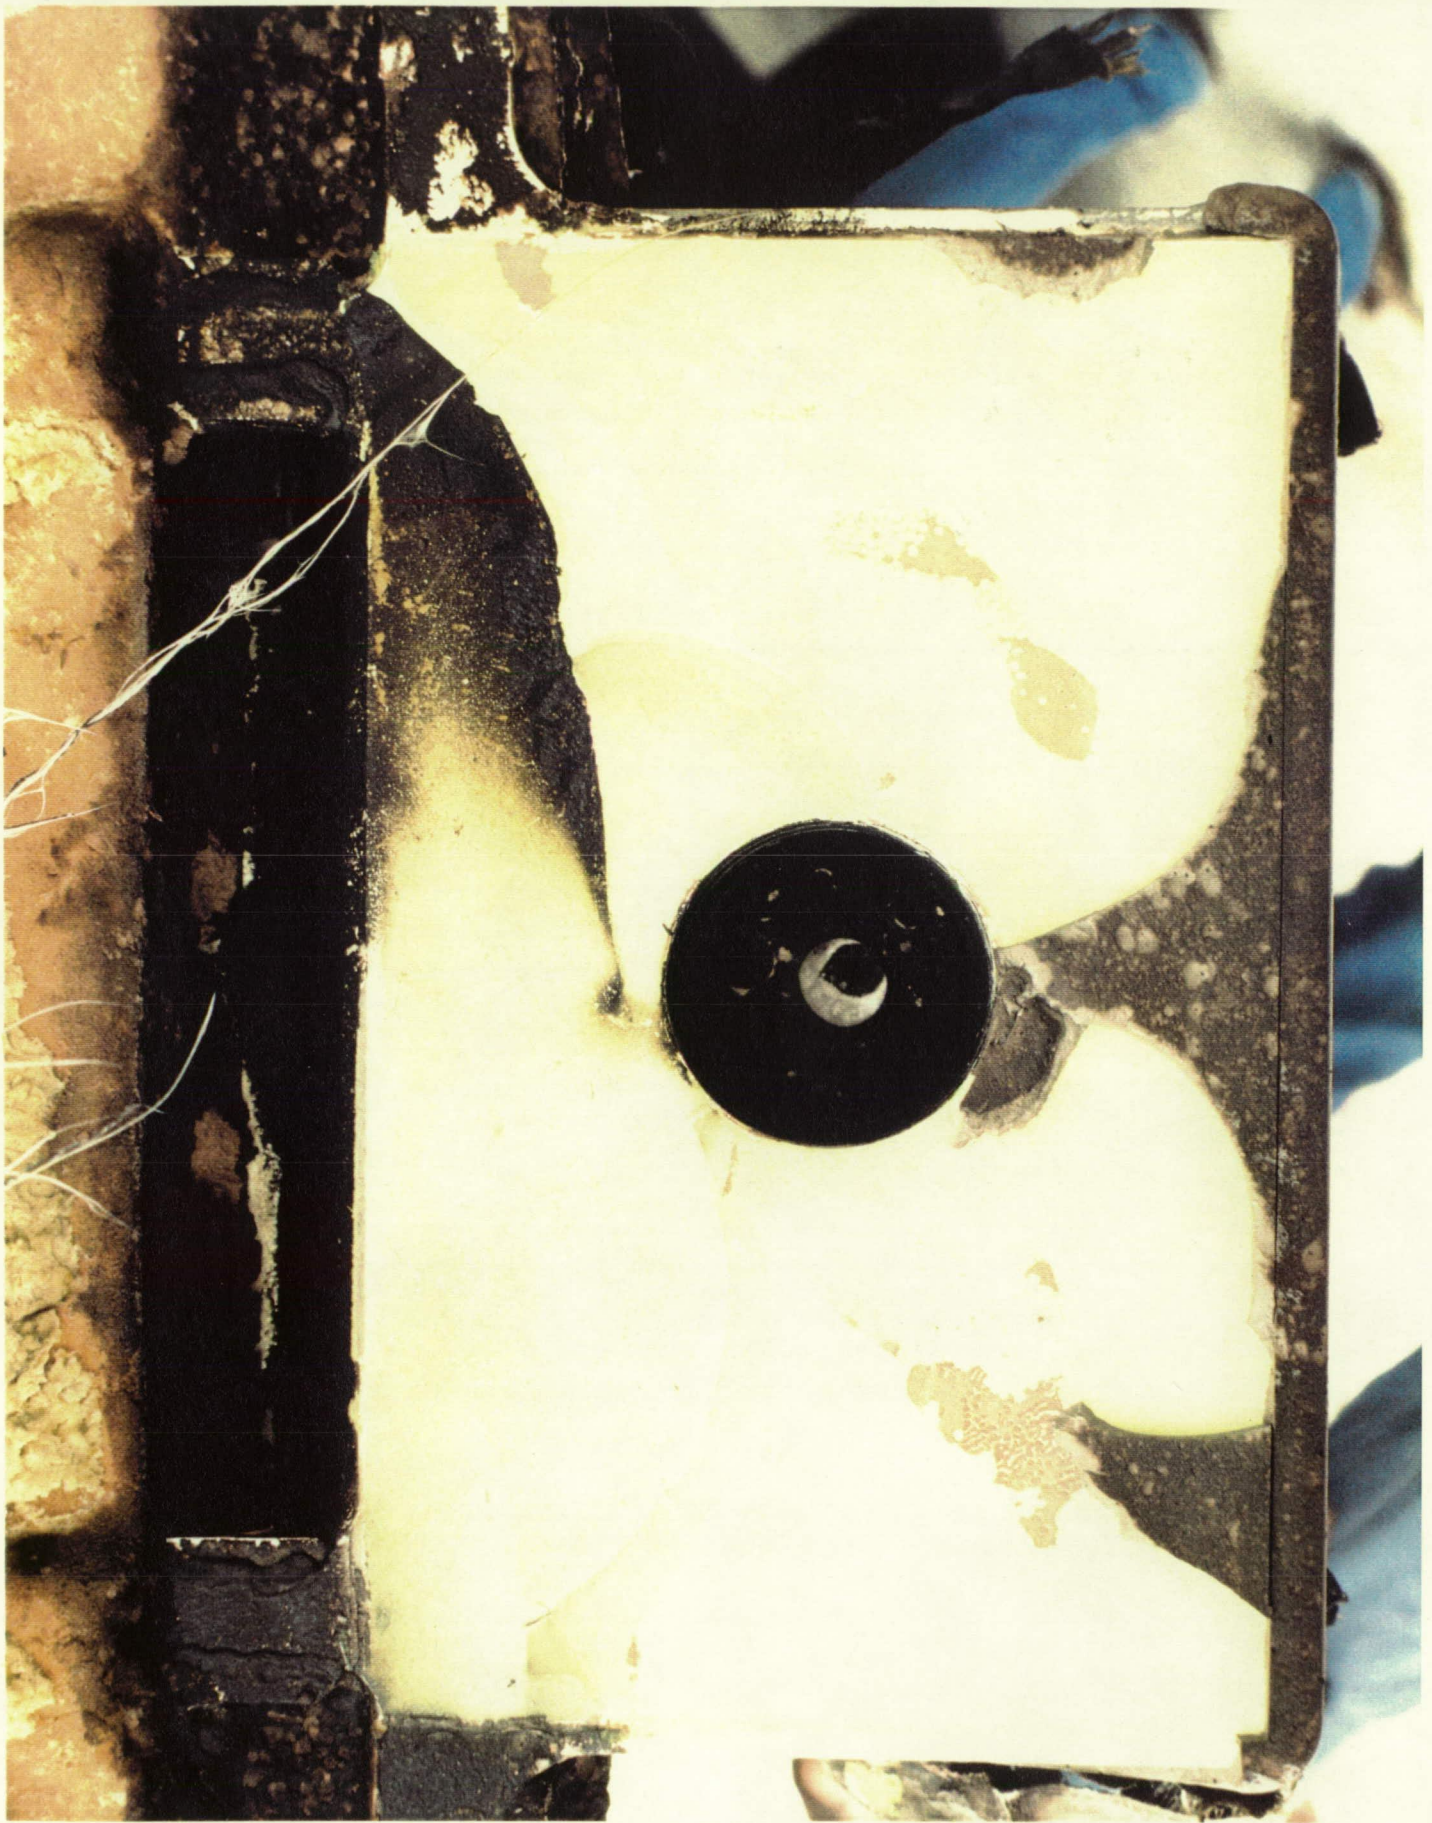
A piece of the HDP #8 EPON shim was missing prior to water impact (sooted/charred substrate).

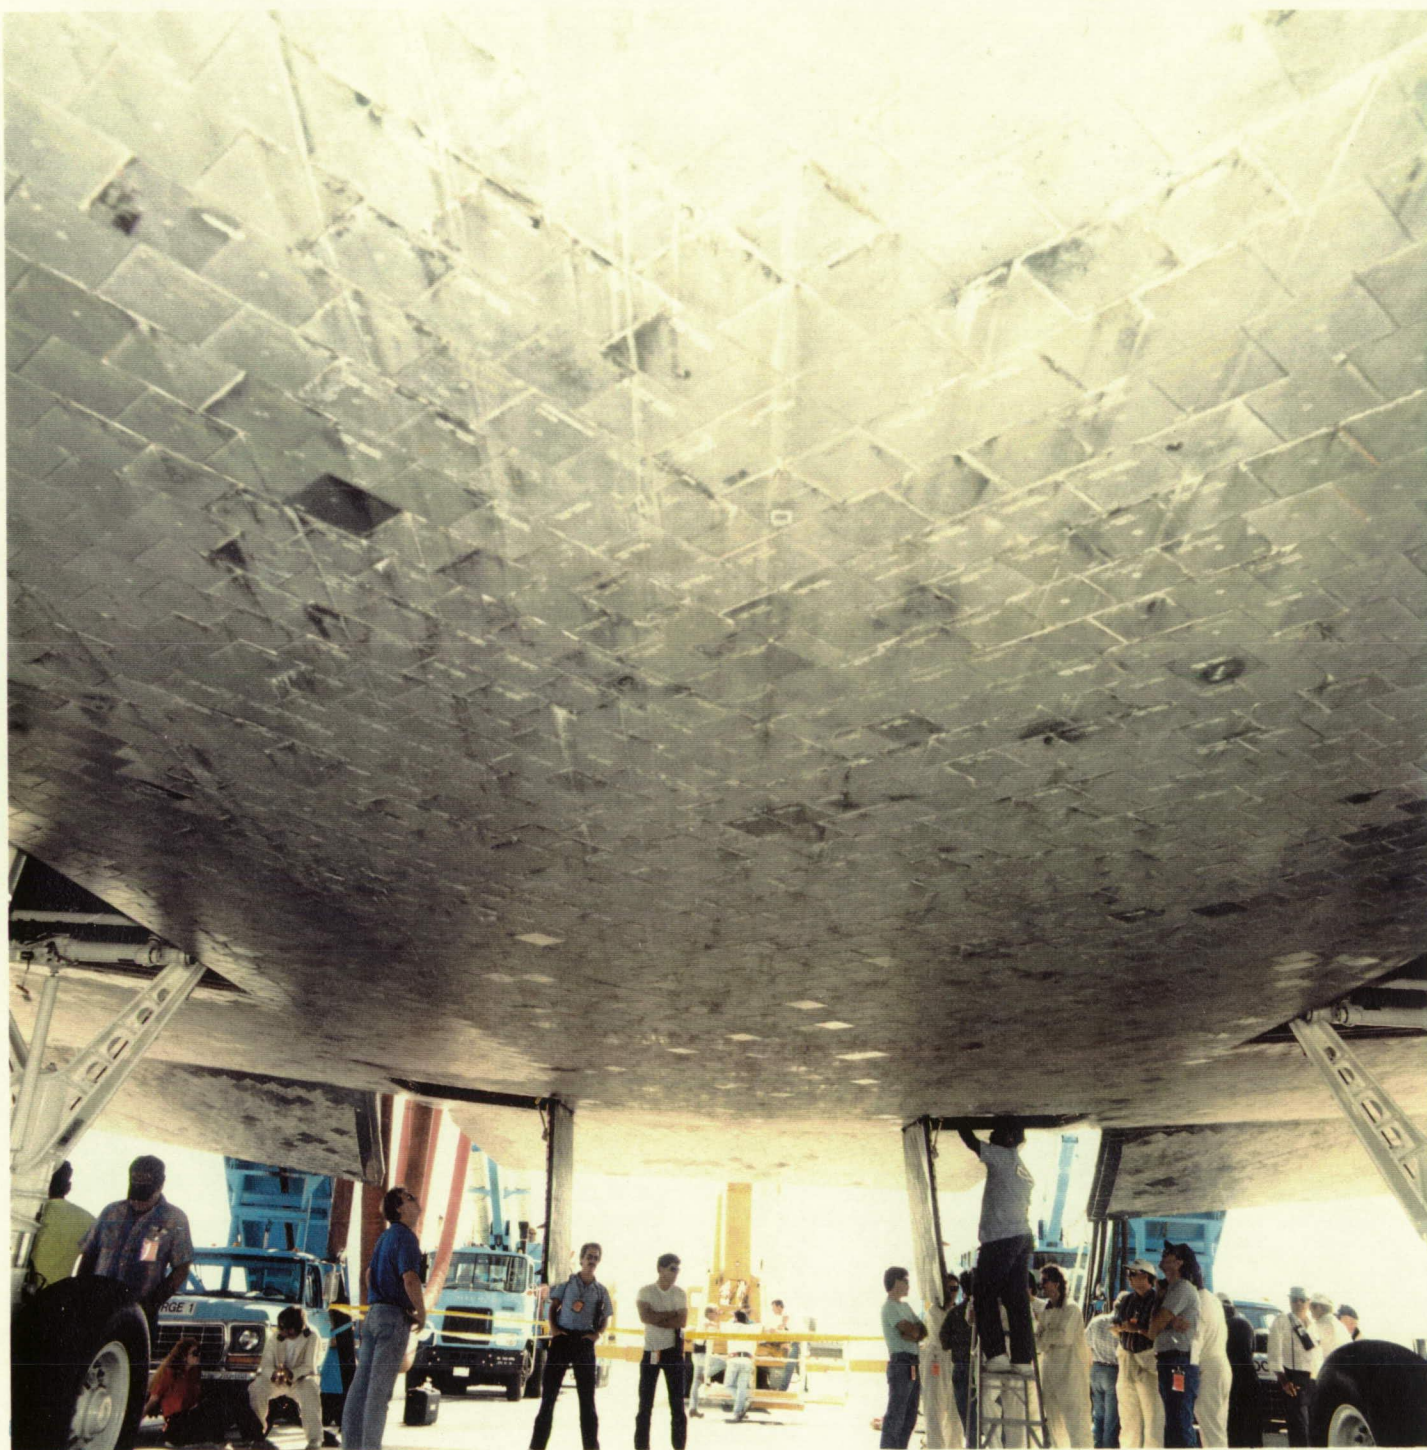
The Orbiter lower surface tiles sustained a total of 152 hits, of which six had a major dimension of 1-inch or greater. The distribution of tile damage hits does not suggest a single source of ascent debris, but indicates a shedding of ice and/or TPS debris from random sources.

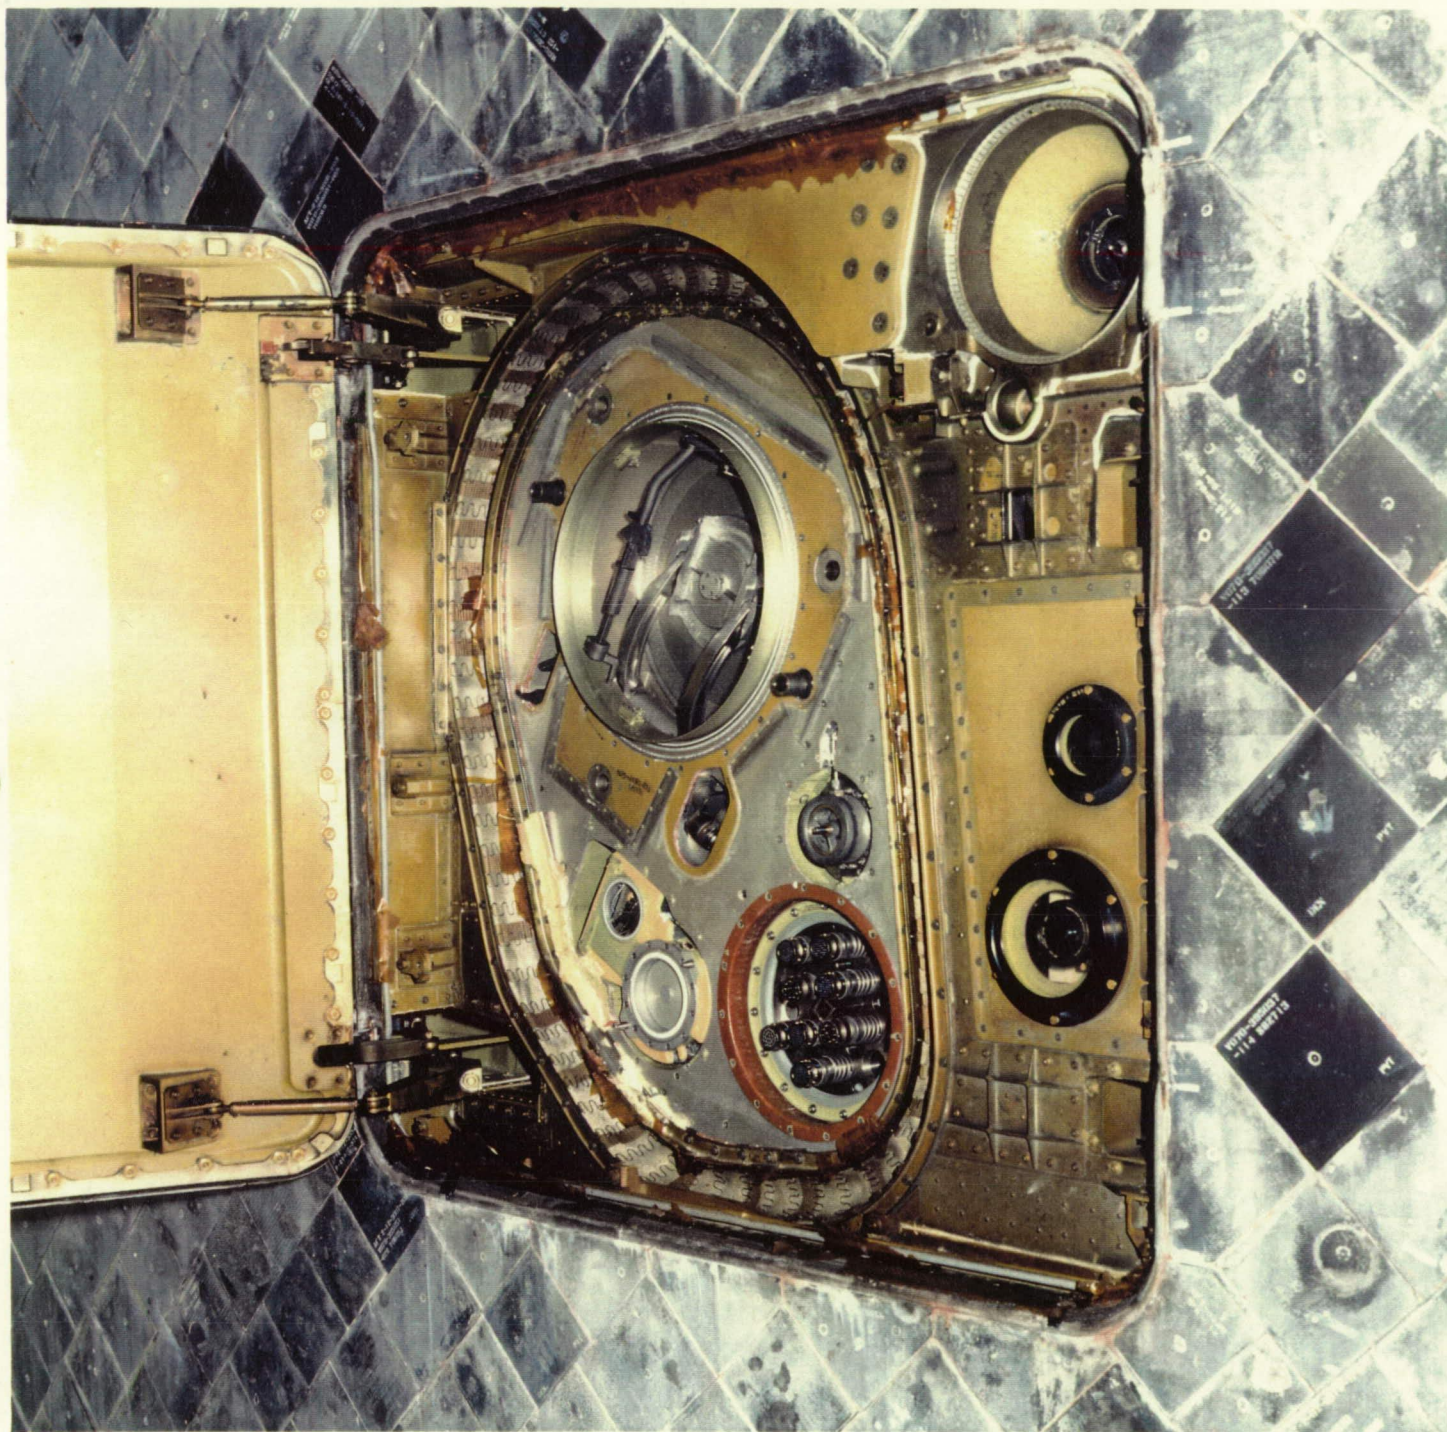
Overall view of the LH2 ET/ORB umbilical. All separation ordnance devices functioned properly. No flight hardware was found on the runway below the umbilical when the ET door was opened.

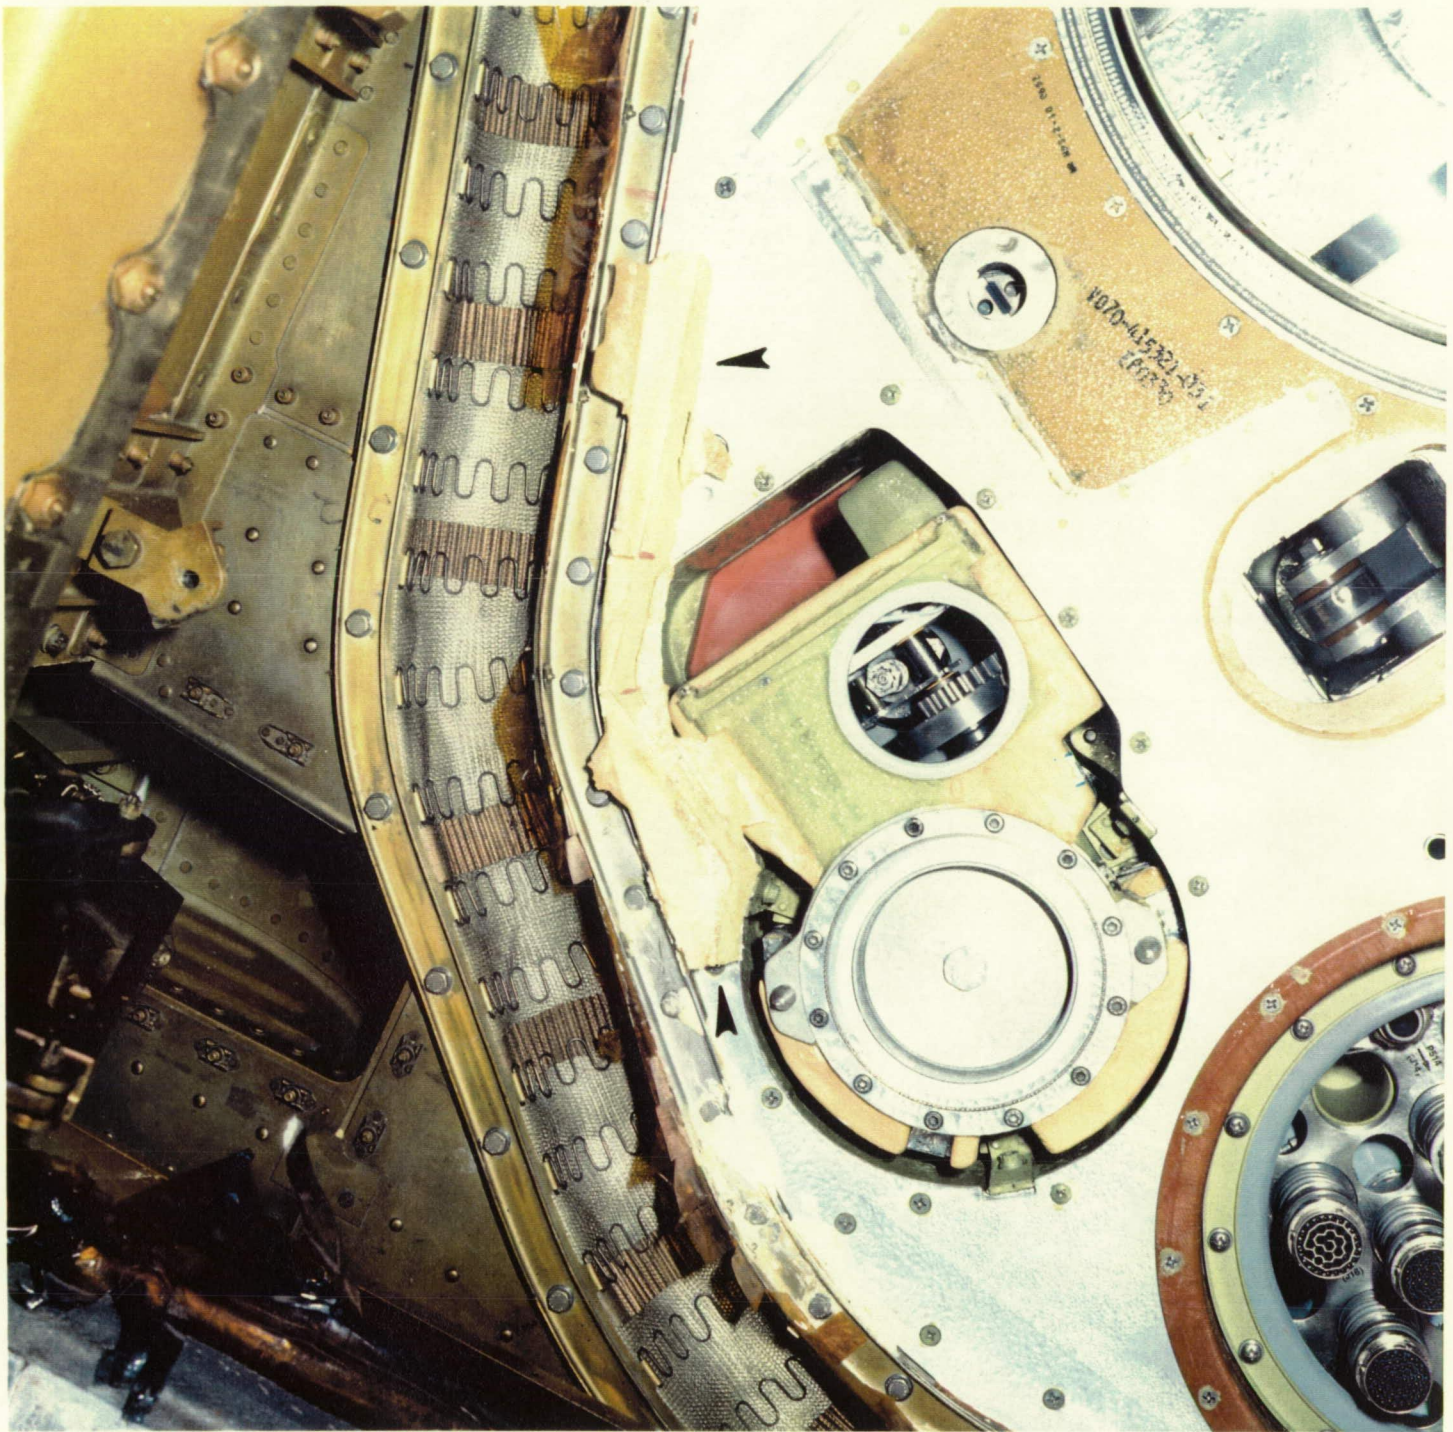
A section of the ET/ORB LH2 umbilical purge seal and closeout foam was still attached to the interface plate/disconnect. The missing section was visible in the separation camera films.

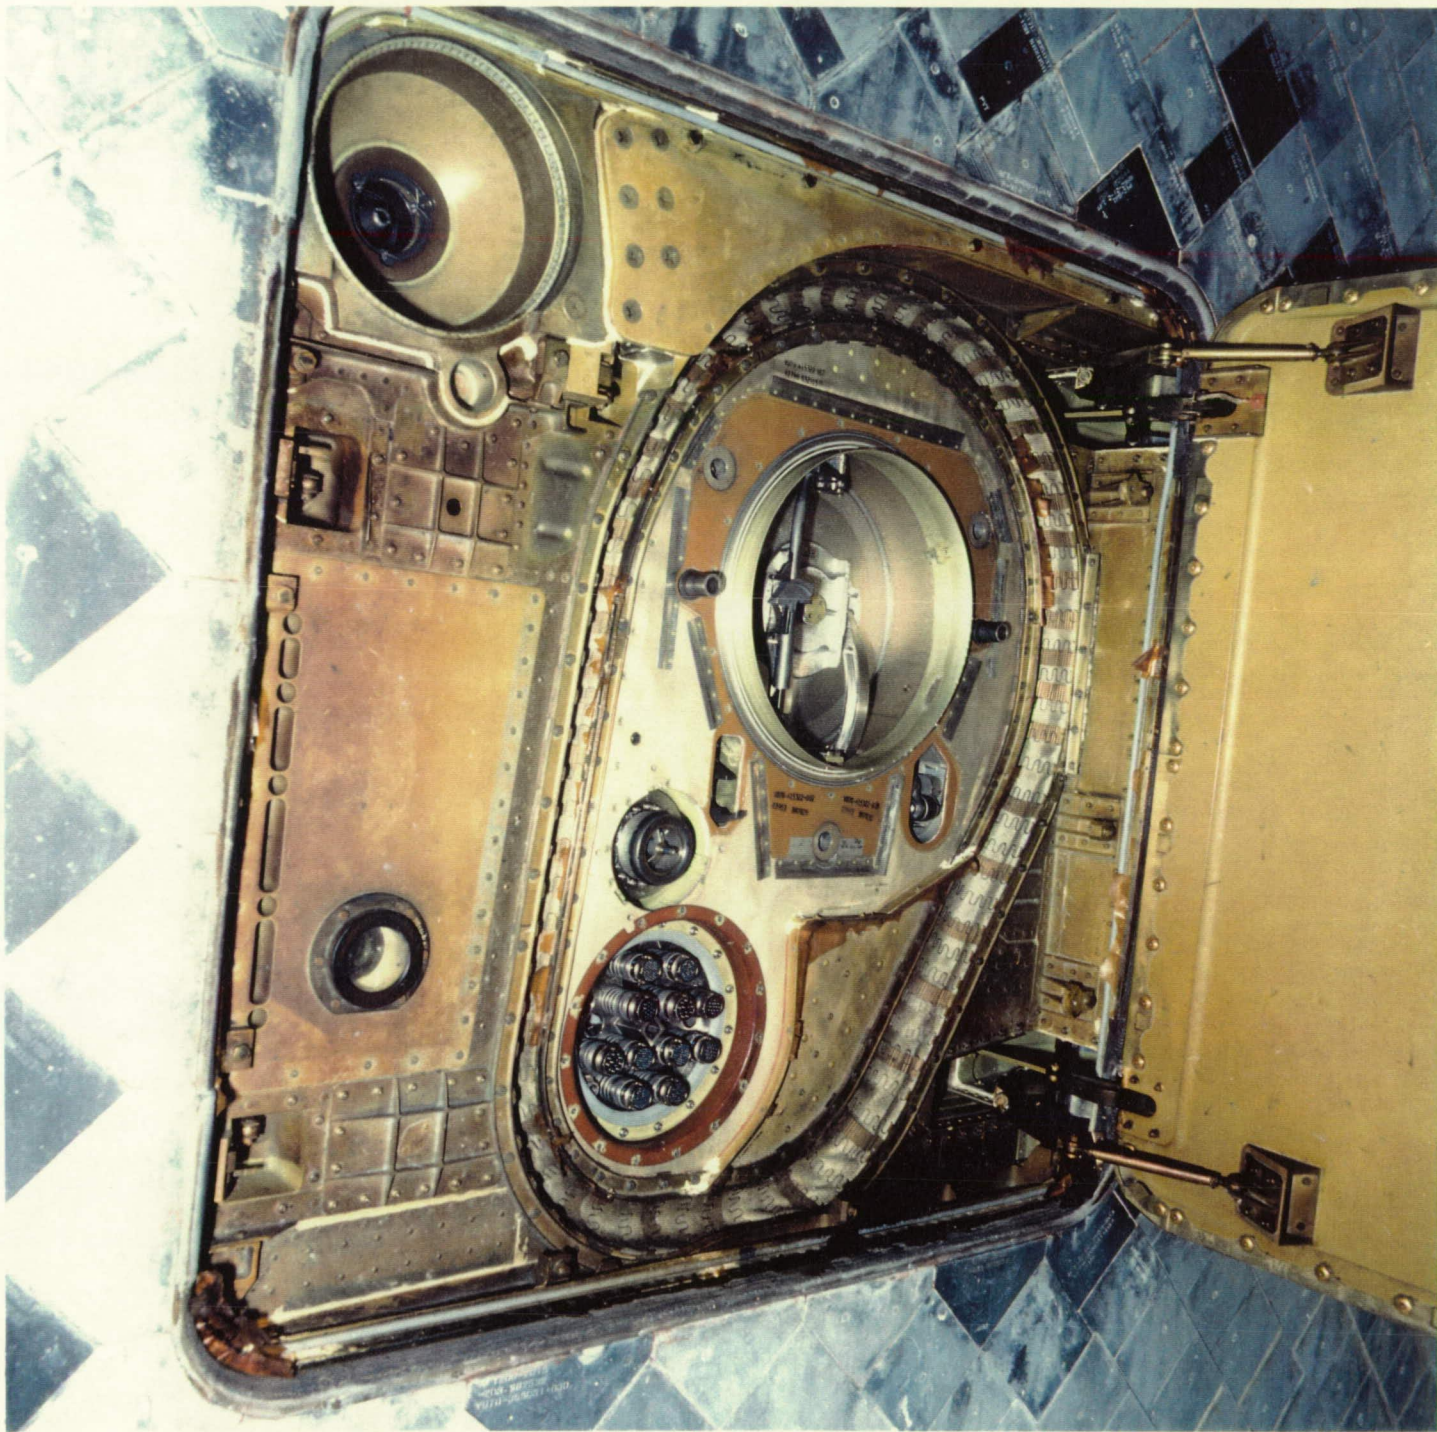
Overall view of the L02 ET/ORB umbilical. All separation ordnance devices functioned properly. No flight hardware was found on the runway below the umbilical when the ET door was opened.

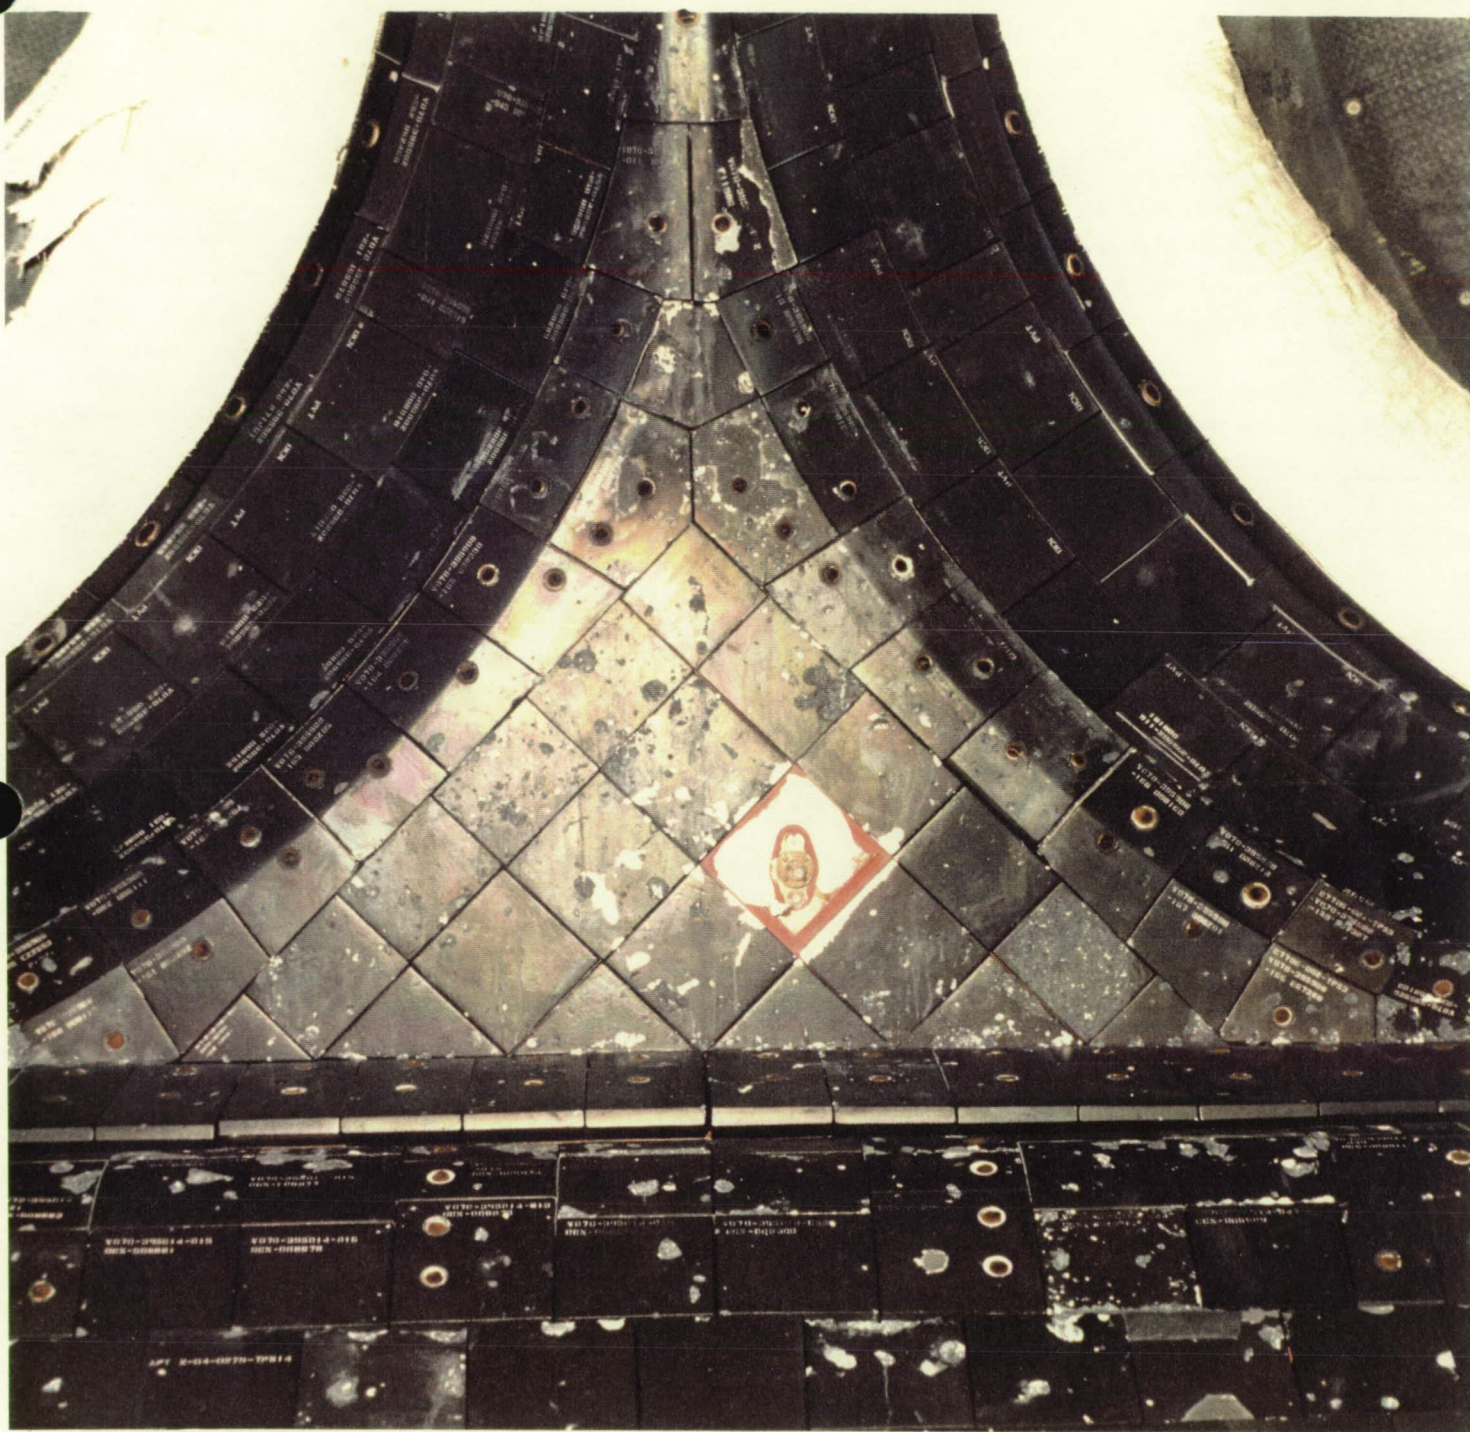
The majority of tile V070-395093-016 was missing from the base heat shield between SSME #2 and #3. This tile, which covers a calorimeter, sustained an in-plane failure, leaving the strain isolation pad and an attached layer (approximately 0.3 inches thick) of densified tile material in the cavity. An In-Flight Anomaly (IFA) was taken. In addition to the missing tile, an 8 by 6 by 0.5-inch tile damage site was present on the base heat shield adjacent to SSME #1 (at approximately the 7:00 o'clock position). This damage site appeared to have been caused by a dense object and may have been caused by the lost tile. This flight marked the fourth use of the Orbiter drag chute. The drag chute appeared to have functioned nominally. All drag chute hardware was recovered and showed no signs of abnormal operation. The only unexpected flight hardware found on the runway was a tile gap filler from the aft fuselage sidewall.

The majority of tile V070-395093-016 was missing from the base heat shield between SSME #2 and #3. This tile, which covered a calorimeter, sustained an in-plane failure leaving the strain isolation pad (SIP) and an attached layer of densified tile material in the cavity.

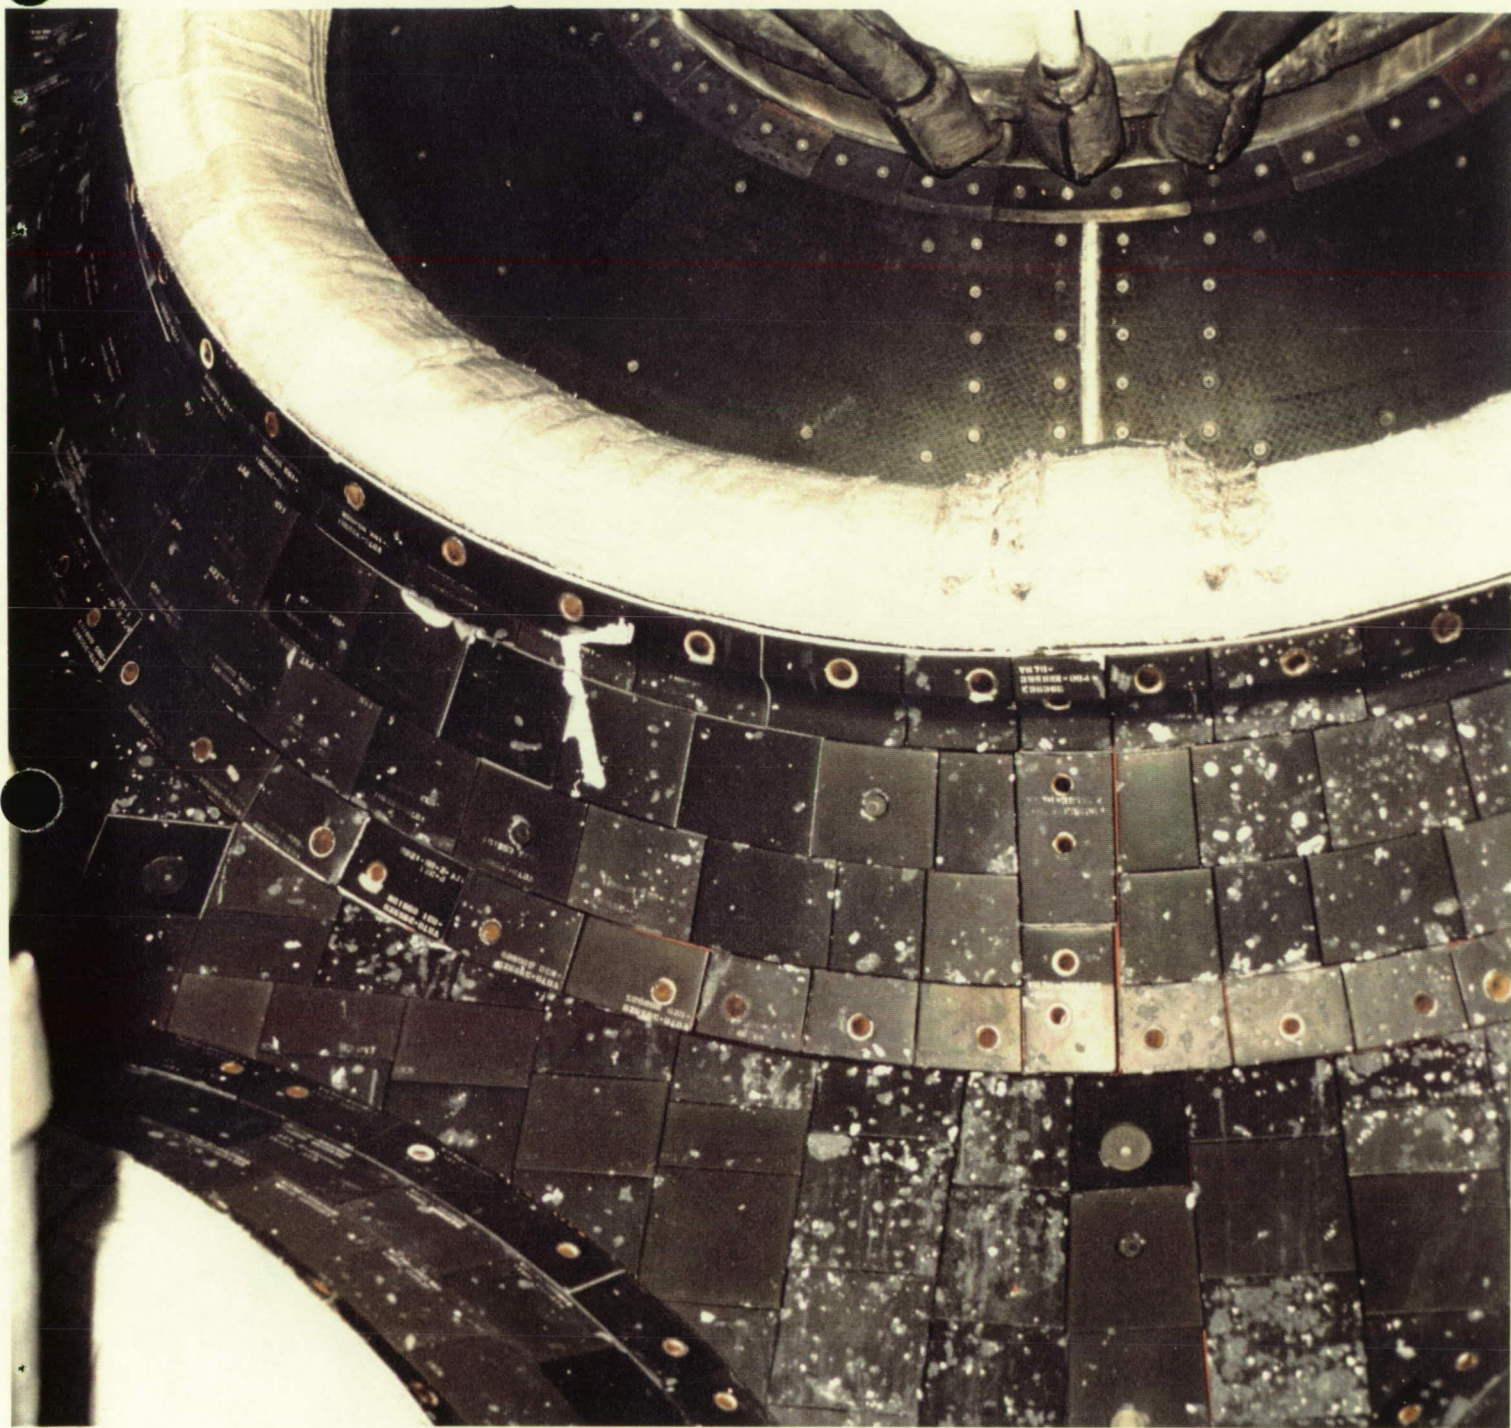
An 8" x 6" x 0.5" tile damage site was present on the base heat shield adjacent to SSME #1 (at approximately the 7:00 o'clock position). This damage site appeared to have been caused by a dense object and may have been hit by the lost tile between SSME #2 and #3.

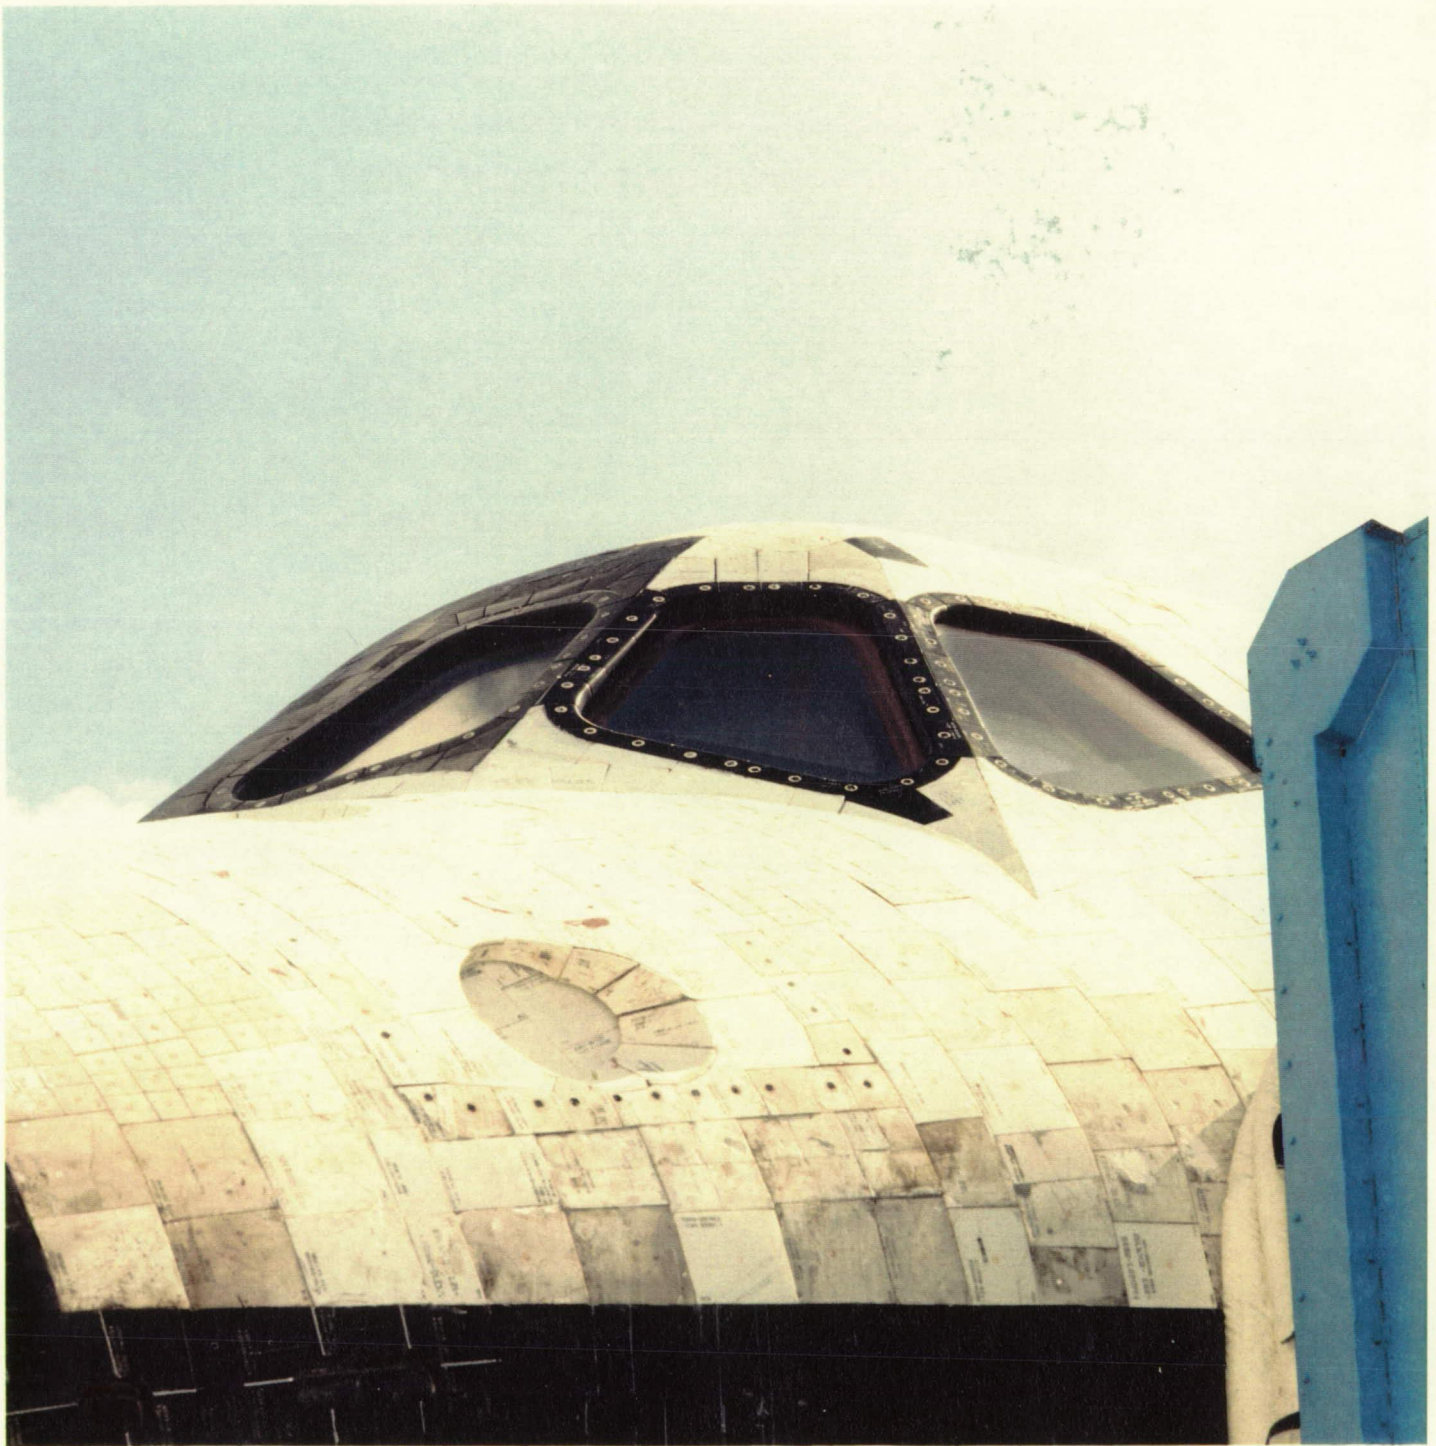
Hazing on the Orbiter windows was light and considered to be less than usual. A large number of tile impact sites (72 with 2 larger than 1-inch) occurred on the perimeter tiles around the forward facing windows. Most of the hits were small and shallow in depth.

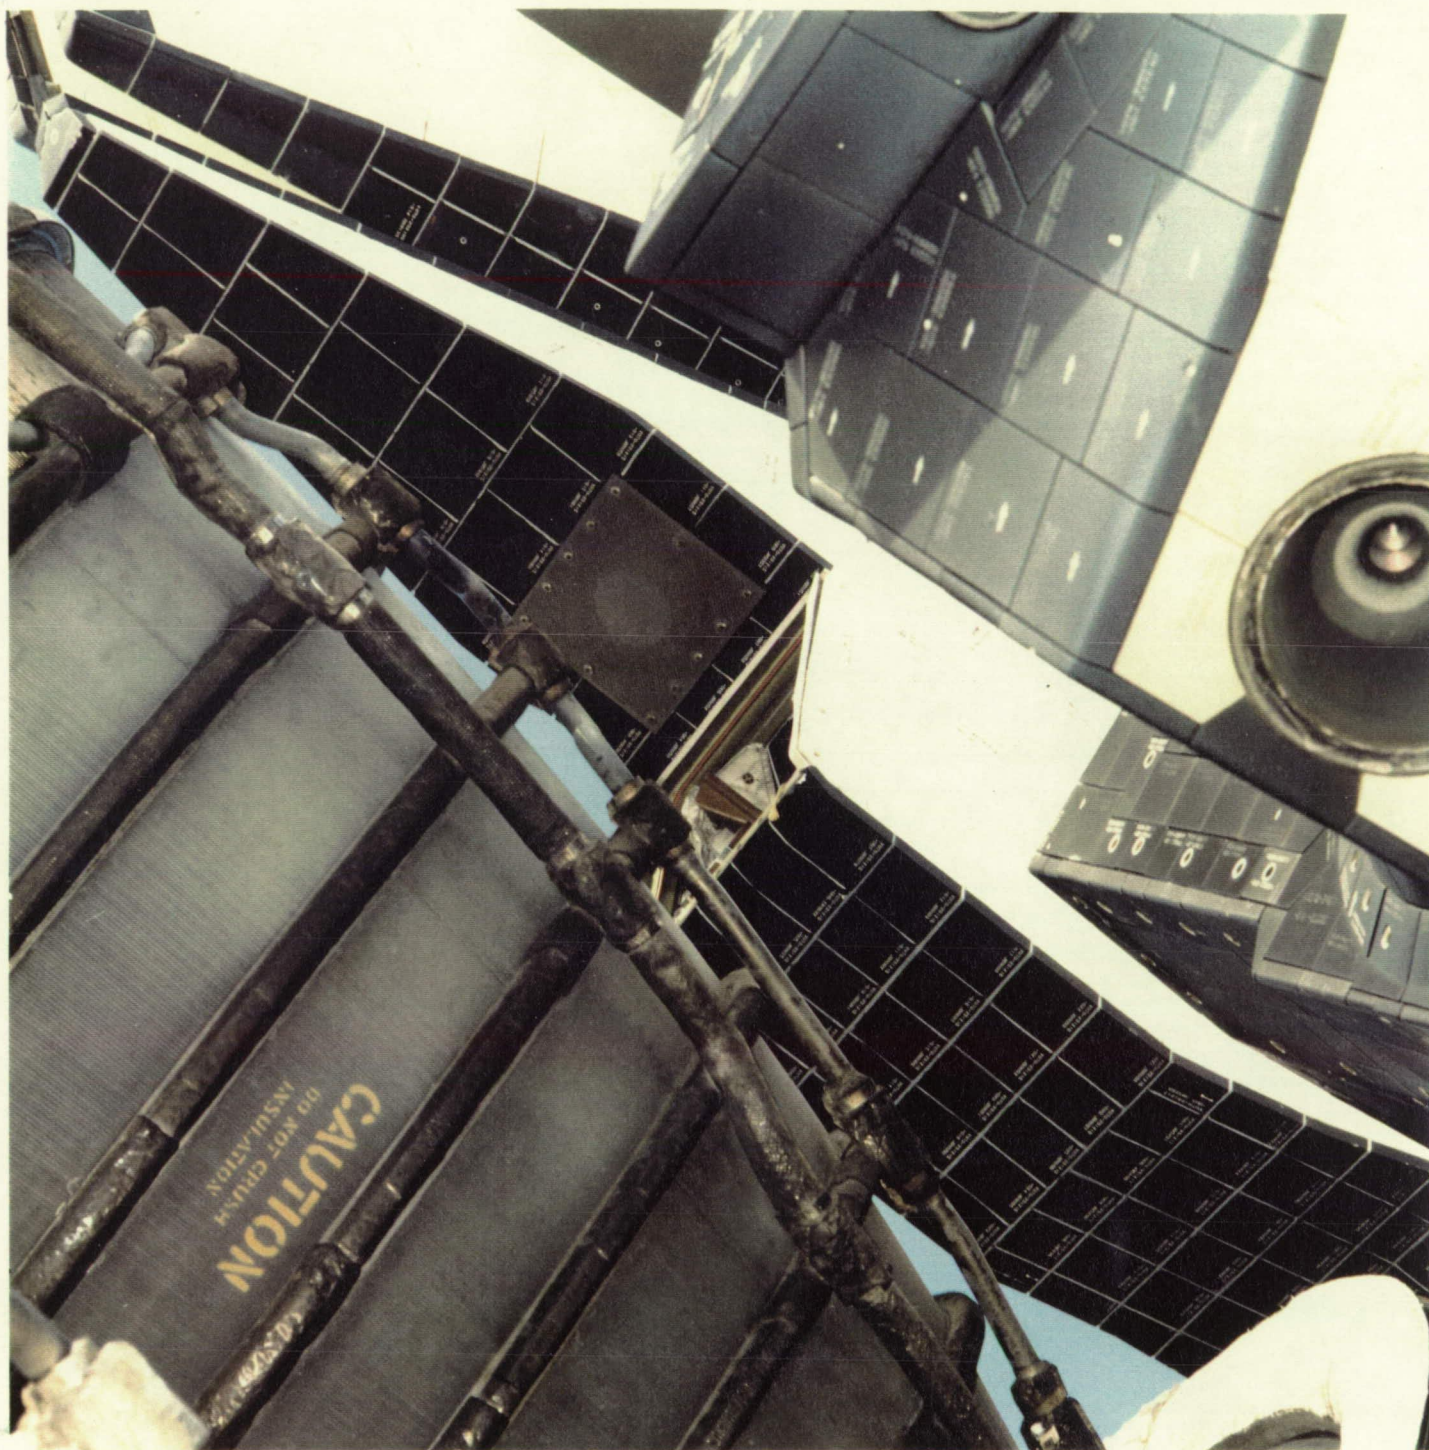
Fourth use of the Orbiter drag chute occurred normally. A tile on the lower (-Z) right edge of the drag chute compartment opening was slightly damaged by separation of the chute compartment door. Similar damage has been observed after every previous use of the drag chute.

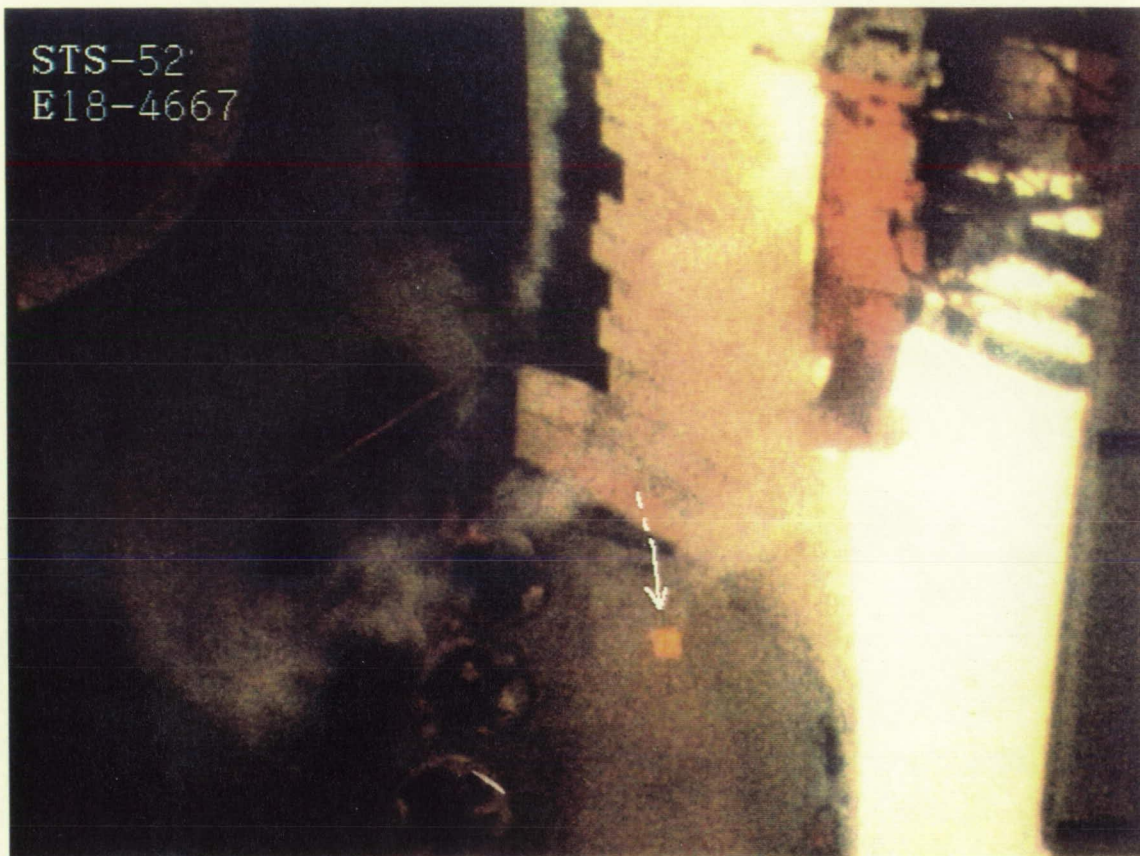
Figure 2.1.2.1 Square-shaped Debris falls from the LH2 TSM Area at Liftoff

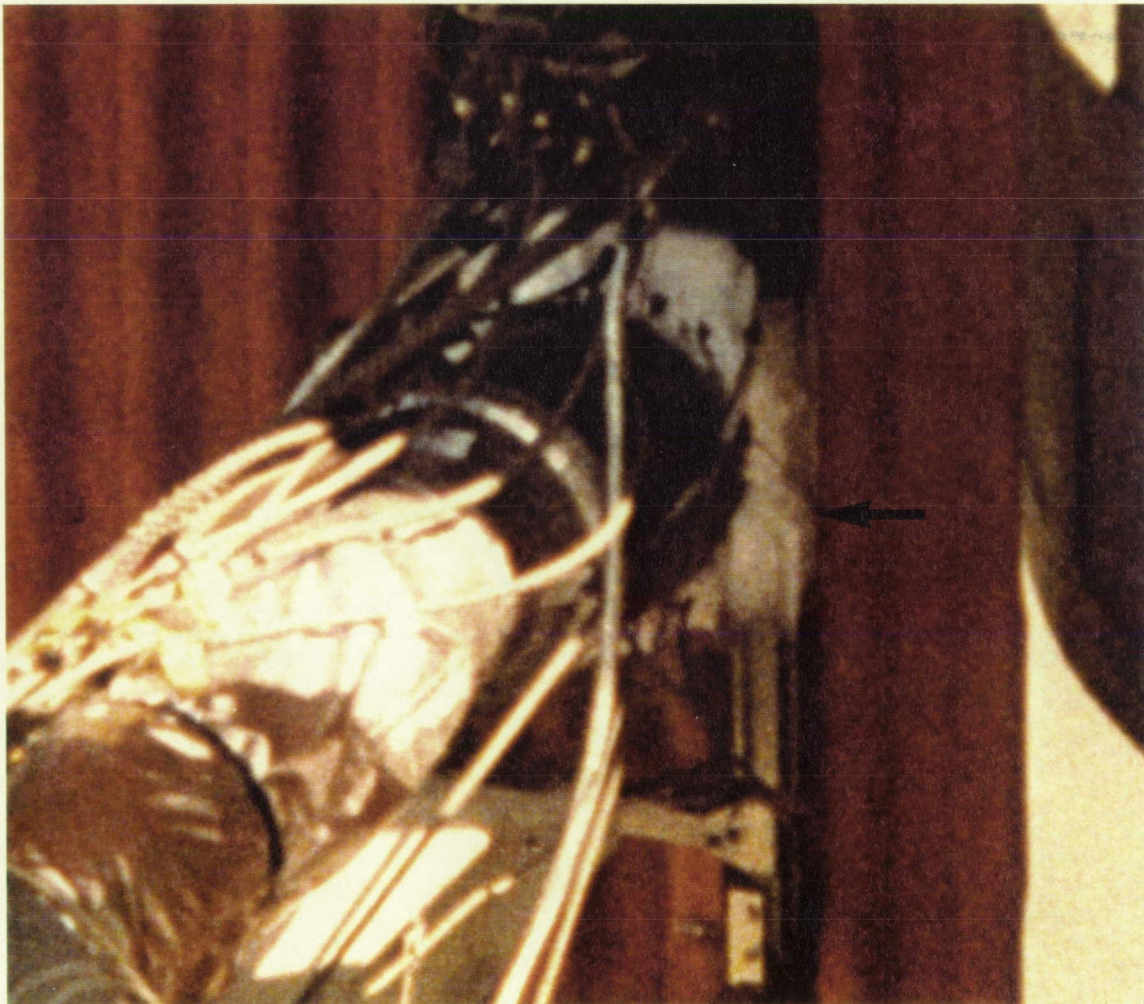
Ice was seen on the GH2 vent arm carrier plate disconnect. Multiple pieces of white debris (probably ice) were seen to fall from the GH2 vent arm during retraction. None of the ice debris appeared to strike the vehicle. No further analysis is expected.

Figure 2.1.2.3 Ice Noted on GH2 Vent Arm Carrier Plate

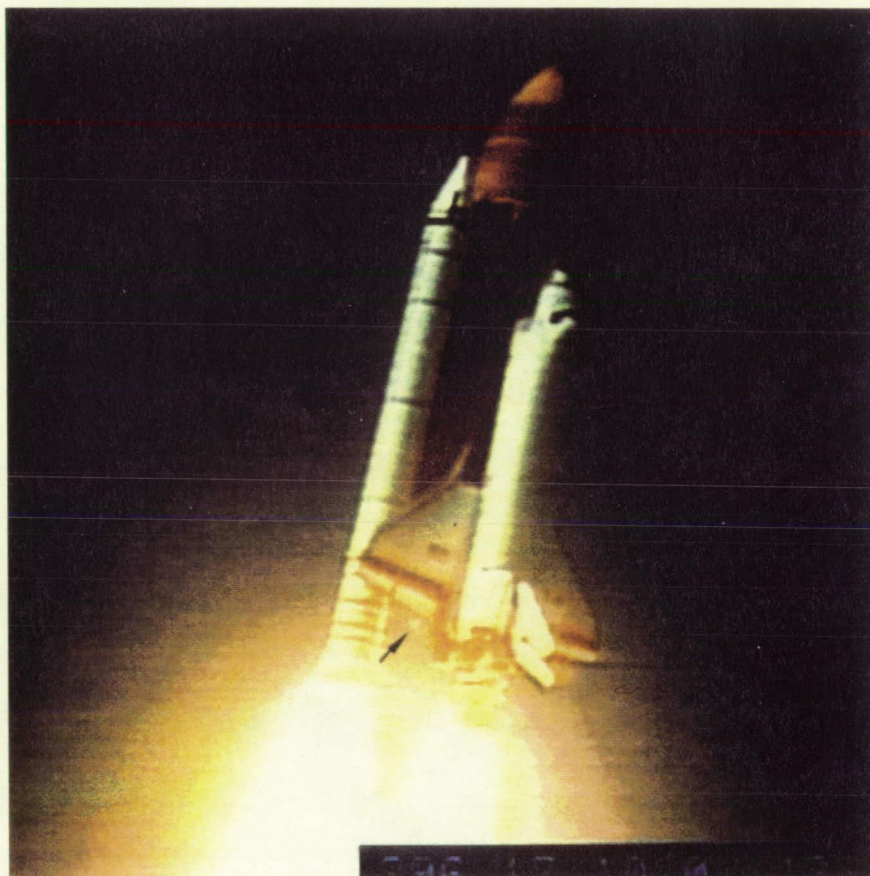
Figure 2.1.3.3 Large Piece of White Debris seen below Left Inboard Elevon after Roll Maneuver
